Enhanced Preliminary Assessment Report:

Youngs Lake Army Housing Units
Renton, Washington

November 1989

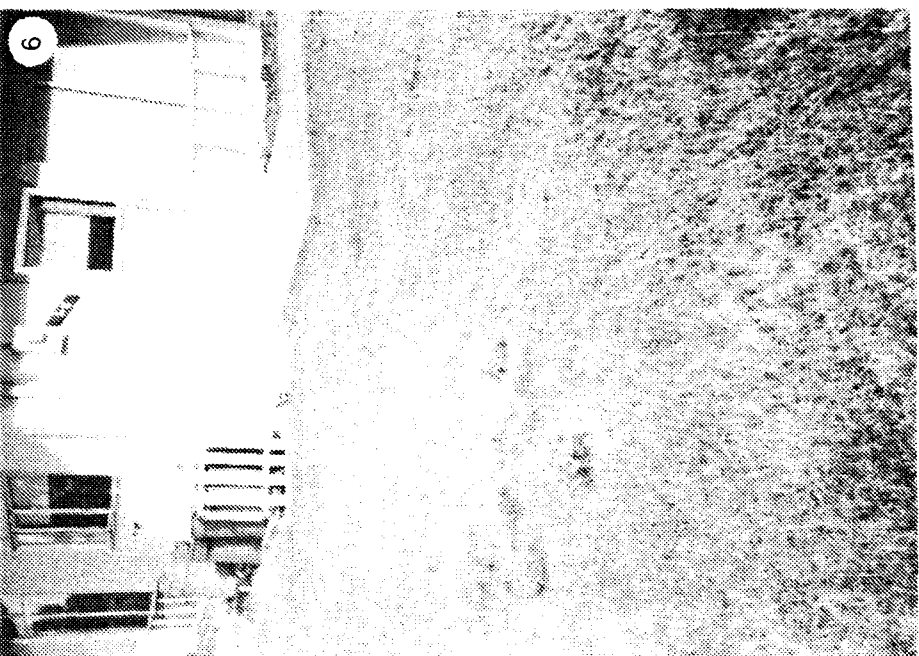
7

7. Wall of a house insulated with cellulose; the three round marks barely observable are inlet holes for the addition of insulation; the holes are closed with wooden pegs.

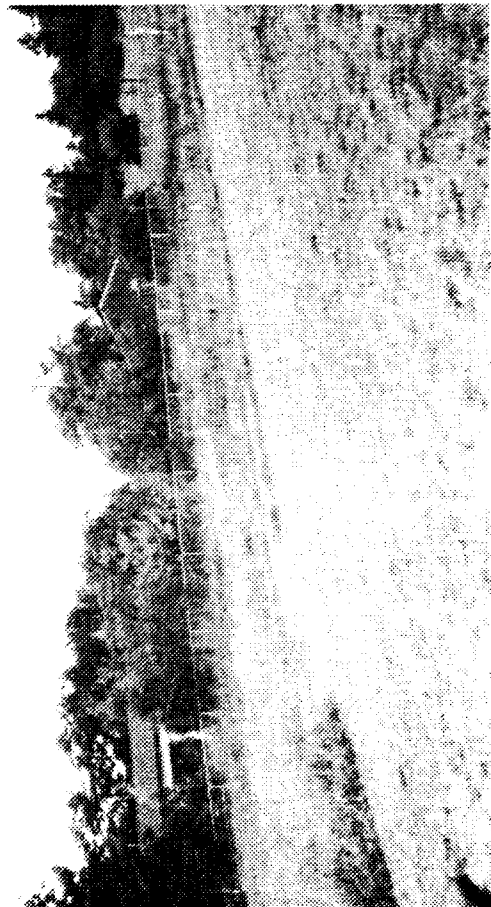
8. Play area, YL-1, in the center of the housing area; several homes surround the play area.
9. A utility pole with an electric transformer mounted at the top; transformers are the responsibility of the public utility company.

The three electrical transformers on the property may contain PCBs. However, these transformers are owned by the public utility. There is no evidence of spills or leaks from any of the transformers.

It is not known whether the three pole-mounted transformers service the housing site have been tested for the presence of PCBs. The transformers are the property and the responsibility of the utility. No leaks were observed.
